**State of Louisiana  
Department of Natural Resources  
Coastal Engineering Division**

**2005/2006 Annual Inspection  
Report**

**EAST MUD LAKE MARSH  
MANAGEMENT PROJECT  
(CS-20)**

November 3, 2005  
Cameron Parish

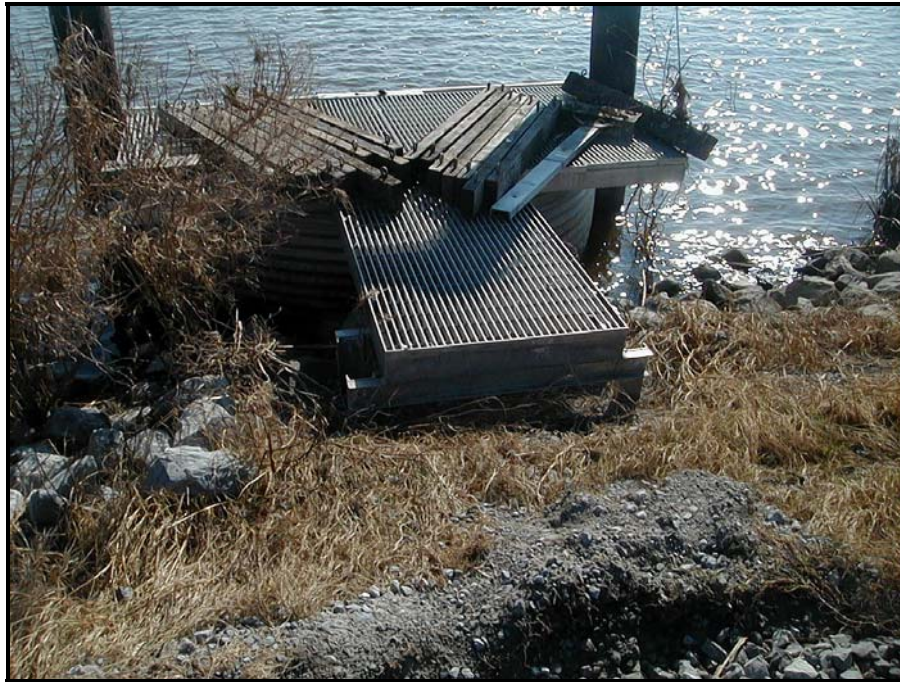
The overall condition of Structure No. 6 appears to be very good. Water level gauges weren't available near the structure but read +1.7 NAVD at Structure No. 7 just east of Structure No. 6. The timber piles, stop logs, grating, etc. are in good condition. Rock placed around the outlet side of the structure has held up well and stabilized the shoreline. Some minor erosion has occurred on the westerly pipe structure near the grating along the road. The end of the outlet pipes are clogged with marsh and other debris. The padlocks on the stop log locking devices have rusted, but since these structures are seldom operated, it was decided not to replace them at this time. As a result of the inspection of Structure No. 6, LDNR and NRCS agree that stone needs to be added around grating near the access roadway, and clean out ends of both outfall pipes of marsh debris. (Photos: Appendix B, Photo 1).

Photo 1, Structure No. 6 showing erosion at end of grating.

Item	Condition	Physical Damage	Corrosion	Photo #	Observations and Remarks
Steel Bulkhead / Caps	N/A				
Steel Grating	Good			1	Some erosion near end of grating along roadside.
Stop Logs	Good				
Hardware	Fair		Yes		Corrosion on padlocks.
Timber Piles	Good				
Timber Wales	Good				
Galv. Pile Caps	Good				
Cables	Good				
Signage / Supports	Fair				<b>General Note:</b> There are no staff gages at this structure.
Outlet Pipes	Fair			1	The ends of both outlet pipes are clogged with marsh debris.
Earthen Embankment	Good

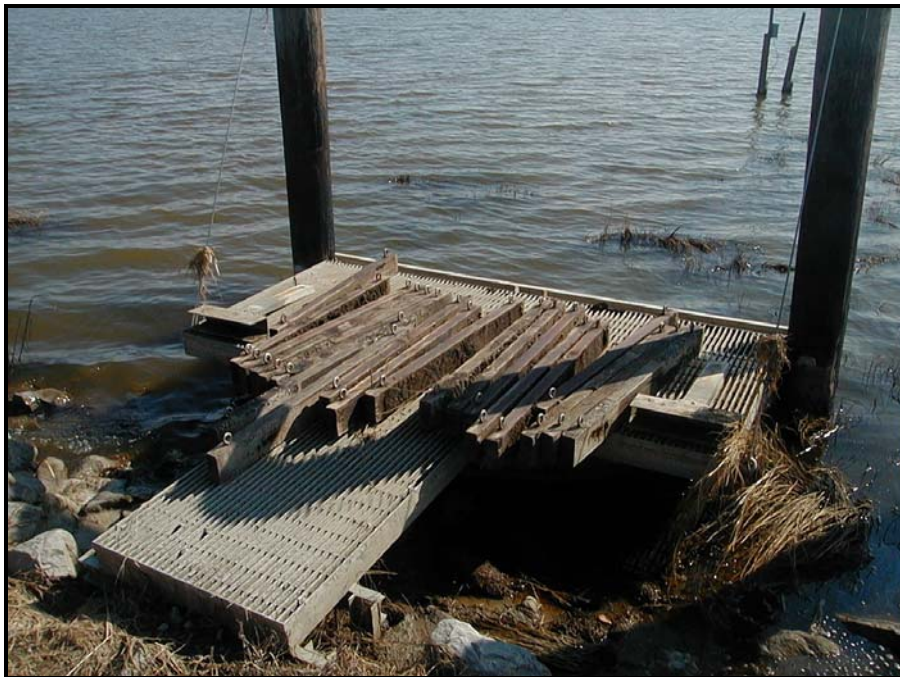
Structure No. 7 appears to be in very good condition. Water level gage on the inside was leaning and not readable and the outside gage was +1.7. Both ends of this structure are clogged with marsh debris and have silted up. Minor erosion also has occurred at the end of the grating along the road. LDNR and NRCS agree that stone needs to be added around grating near access roadway, clean out marsh debris from the inlet and outlet sides of the structure and replace staff gage on the inside of the structure. (Photos: Appendix B, Photo 2).

Photo 2, Structure No.7 showing marsh debris/siltation and minor erosion at grating.

Item	Condition	Physical Damage	Corrosion	Photo #	Observations and Remarks
Steel Bulkhead / Caps	N/A				
Steel Grating	Good				Minor erosion at end of grating along roadside.
Stop Logs	Good				
Hardware	Fair		Yes		Corrosion on padlocks.
Timber Piles	Good				
Timber Wales	Good				
Galv. Pile Caps	Good				
Cables	Good				
Signage / Supports	Good				
Satff Gages	Fair				Inside gage was leaning and not readable.
Inlet/Outlet Pipe	Fair			2	Inlet and outlet pipes are clogged with marsh debris.
Earthen Embankment	Good

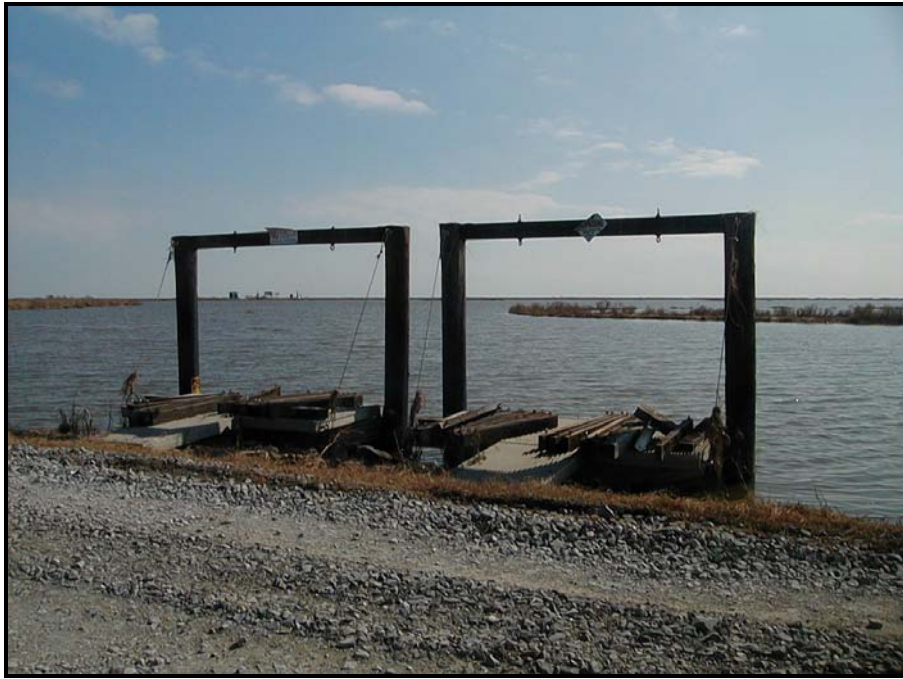
Structure No. 8 appears to be in very good condition. Water level gauges were unavailable. The end of the outlet pipes need to be cleaned out. It appears very little flow is going through the pipes due to washover of the access road rock material into the water. LDNR and NRCS agree that this structure requires clean out of the ends of outlet pipes, and replace staff gages inside and outside of the structure. (Photos: Appendix B, Photos 3).

Photo 3, Structure No.8, view looking south.

Item	Condition	Physical Damage	Corrosion	Photo #	Observations and Remarks
Steel Bulkhead / Caps	N/A				
Steel Grating	Good				
Stop Logs	Good				
Hardware	Fair		Yes		Corrosion on padlocks.
Timber Piles	Good				
Timber Wales	Good				
Galv. Pile Caps	Good				
Cables	Good				
Signage / Supports	Good				
Staff Gages	Poor				Staff gages inside and outside of the structure are missing.
Inlet/Outlet Pipe	Fair			3	Very little flow through pipes, clogged with washover of rock from roadway.
Earthen Embankment	Good

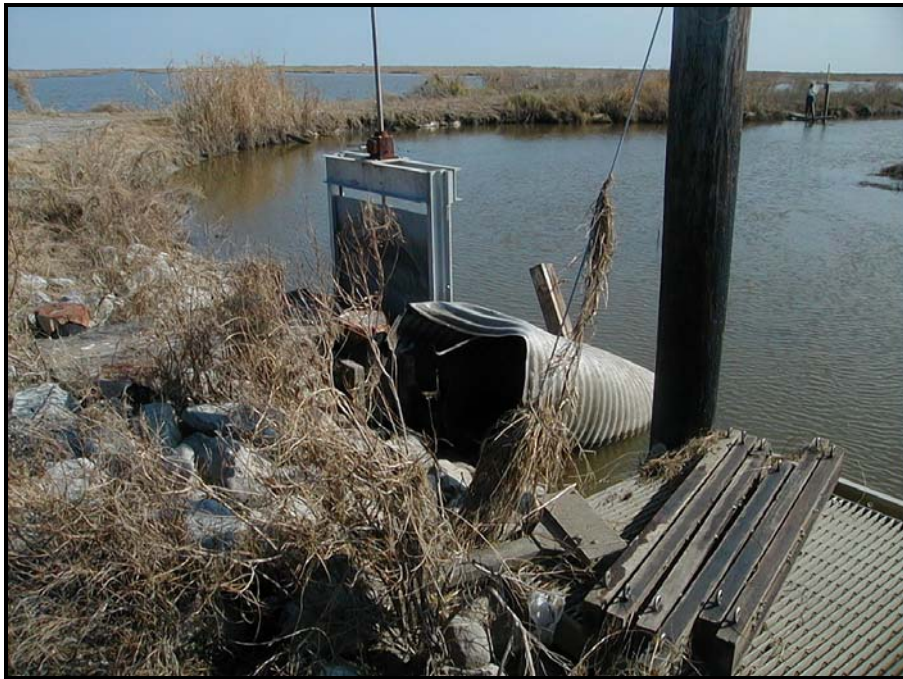
Structure No. 9a is in good condition. The staff gage on the inside was leaning and not readable and the gage on the outside was +1.1 NAVD. Salinity on the inside was 20.8 ppt and 25.0 ppt on the outside. A section of corrugated metal culvert debris has been lodged up against this structure. The handle on the outlet pipe flapgate has been broken off. Upon visual inspection, we noticed that there was slight erosion on the earthen wing-walls of the structure. LDNR and NRCS agree that this structure requires removal of the metal pipe and repair of the flapgate handle. (Photos: Appendix B, Photos 4 & 5).

Photo 4, Structure 9a & 9b, showing metal culvert debris lodged on structures.

Item	Condition	Physical Damage	Corrosion	Photo #	Observations and Remarks
Steel Bulkhead / Caps	N/A				
Steel Grating	Good			4, 5	<b>GENERAL NOTE:</b> (1) Replace plastic stem cover on sluice gate. (2) Sandblast/cleanup gear drive on sluice gate. (3) Metal culvert debris lodged against the structure.
Stop Logs	Good				
Hardware	Fair		Yes		Corrosion on padlocks, handle on outlet pipe broken..
Timber Piles	Good				
Timber Wales	Good				
Galv. Pile Caps	Good				
Cables	Good				
Signage /Supports	Good				
Staff Gages	Poor				Staff gage on inside leaning and not readable.
Rip Rap (fill)	Good				
Earthen Embankment	Good				Slight erosion on the earthen wing walls of the structure.

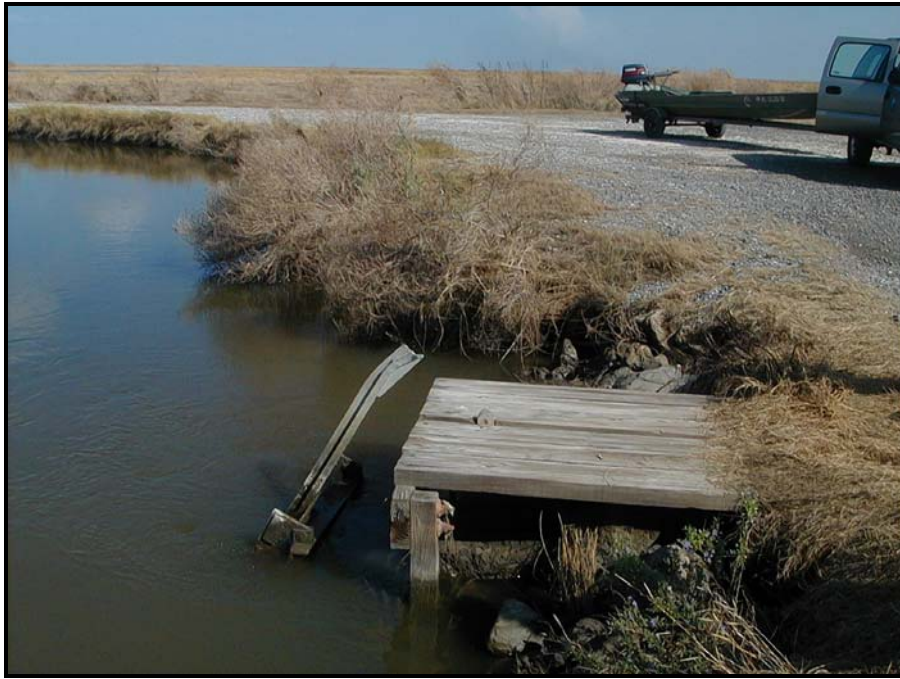
Structure No. 9b is in good condition. The staff gage on the inside was leaning and not readable and the gage on the outside was +1.1 NAVD. Salinity on the inside was 20.8 ppt and 25.0 ppt on the outside. A section of corrugated metal culvert debris has been lodged up against this structure. The handle on the outlet pipe flapgate has been broken off. The gear box on the sluice gate is showing signs of rust and the stem cover is missing. Apache personnel have reported that it, so far, is not a problem; however it will probably need to be addressed. LDNR and NRCS agree that this structure is in operable condition and minor maintenance will be required to sandblast, clean up, paint the gearbox and replace the plastic stem cover, and repair flapgate handle. (Photos: Appendix B, Photos 4 & 5).

Photo 5, Structure 9b, showing broken flapgate handle.

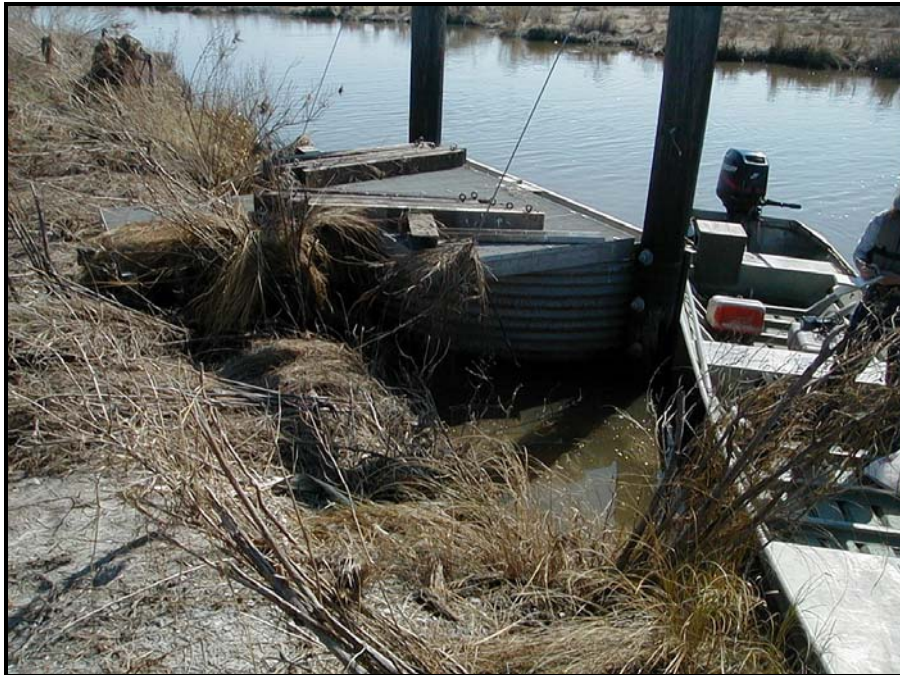
The structure is in good condition. Water level was +1.0 NAVD on the outside. The staff gage on the inside of the structure is missing. Salinity readings were 23.6 ppt on the inside and 23.0 ppt on the outside. There is some erosion of the bank on both the inlet and discharge sides of the structure. Approximately 270 tons of man size rip rap will be required to reinforce the bank around the structure. No additional damage noted from the storm. LDNR and NRCS agree that maintenance work is required to add rip rap and replace staff gage. (Photos: Appendix B, Photo 6).

Photo 6, Structure No. 11, view looking south.

Item	Condition	Physical Damage	Corrosion	Photo #	Observations and Remarks
Steel Bulkhead / Caps	N/A				
Steel Grating	Good				
Stop Logs	Good				
Hardware	Fair		Yes		Corrosion on padlocks.
Timber Piles	Good				
Timber Wales	Good				
Galv. Pile Caps	Good				
Cables	Good				
Signage / Supports	Fair			6	Add staff gage on inside.
Rip Rap (fill)	N/A				
Earthen Embankment	Fair	Yes		6	Bank erosion on inside of structure, 50 feet on right side (east) and 30 feet on left (west). Bank erosion on outside of structure, 20 feet either side of pipe (Approximately 270 tons of rock total).

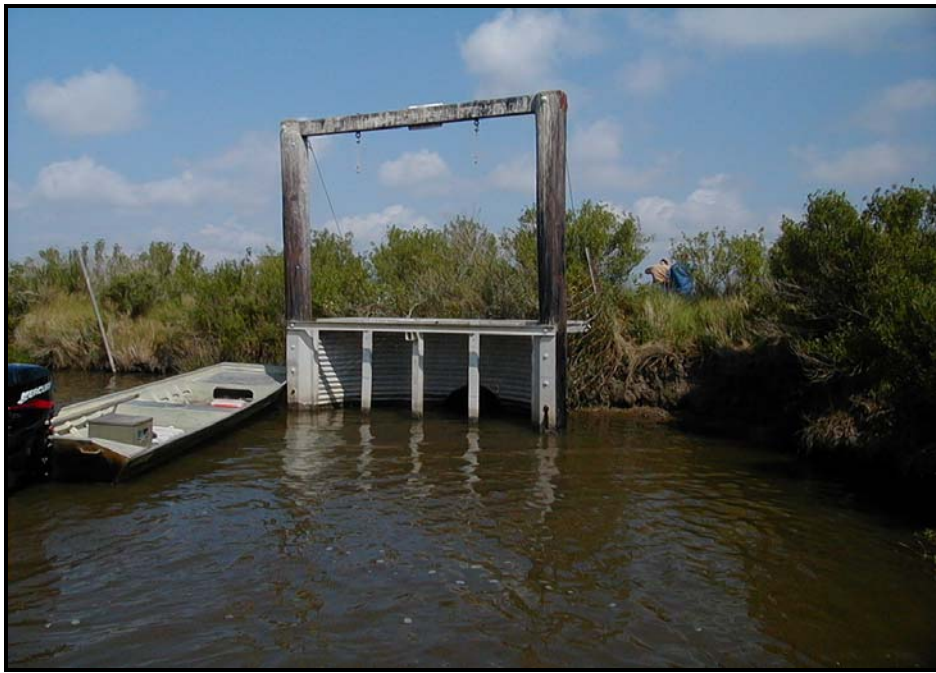
The structure itself is in good condition. Staff gauges inside and outside of the structure are damaged and not readable. Salinity inside the marsh was 23.5 ppt. Erosion was noted along the bank on both the inlet and discharge sides of the structure. The erosion extends on the inlet side from the eastern end of the structure southerly along the step canal for approximately 20 linear feet each side of the structure. Approximately 90 tons of rock will be needed to reinforce the bank around this structure. Additional erosion was noted along the bank on the inlet side of the structure due to Hurricane Rita. LDNR and NRCS agree that maintenance work is required to add rip rap and replace staff gages. (Photos: Appendix B, Photos 7 & 8).

Photo 7, Structure No. 5, March – 2005, showing bankline erosion.

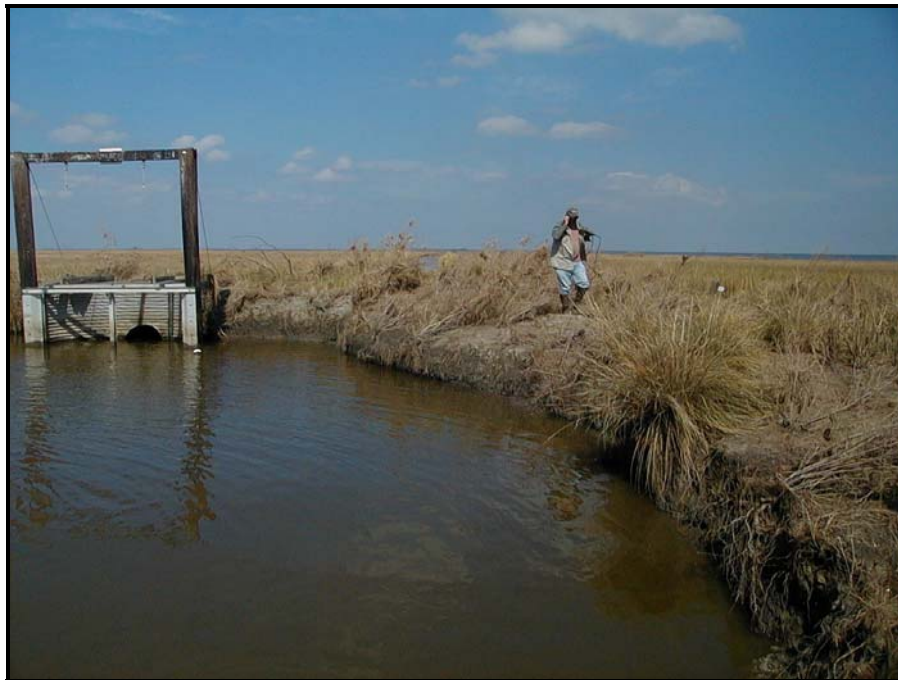
Photo 8, Structure No. 5, November -2005, showing additional bankline erosion along structure and on eastern levee.

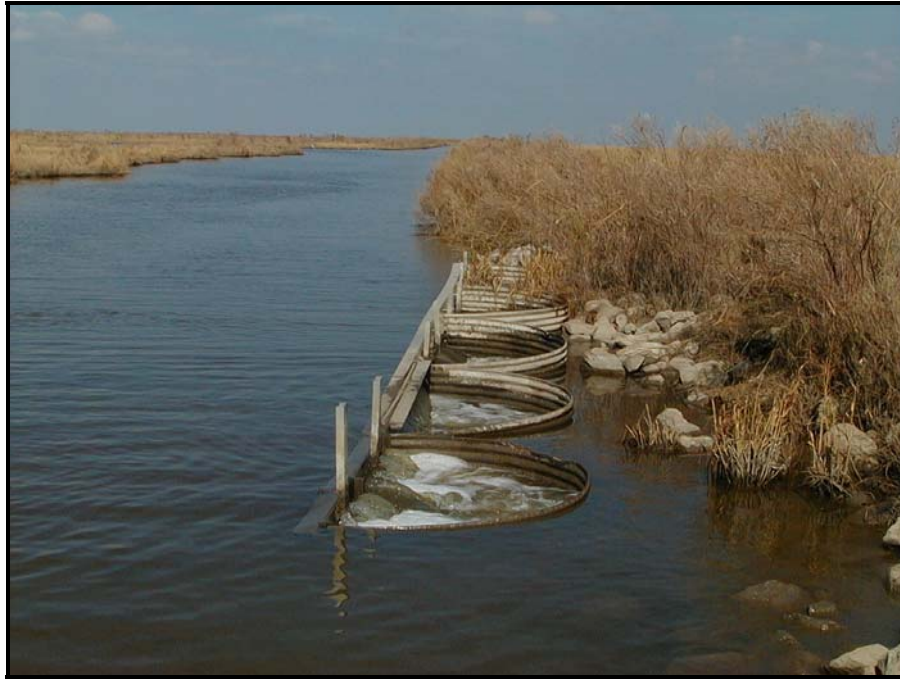
This structure is a pre-existing structure that was incorporated into the CS-20 Project. It is in disrepair and needs to be replaced. A new structure was let out for bids on February 10, 2005, however it was over budget and the bid was rejected. This structure will be replaced with a structure similar to ES-13, and the existing structure will be abandoned in place. Staff gauge reading inside was +1.1 and +0.5 on the outside. Salinity reading on the inside was 23.4 ppt. The structure appeared to be in same condition as pre-storm. (Photos: Appendix B, Photo 9).

Photo 9, Structure No. 4, view looking north.

Item	Condition	Physical Damage	Corrosion	Photo #	Observations and Remarks
Steel Bulkhead / Caps	N/A			9	<b>GENERAL NOTE:</b> Due to severe settlement of the overall structure, it is beyond repair and needs to be abandoned in place, and a new structure built along side.
Steel Grating	Poor				
Stop Logs	Fair				
Hardware	Fair				
Timber Piles	Poor				
Timber Wales	Poor				
Galv. Pile Caps	Good				
Cables	N/A				
Signage / Supports	Good				
Rip Rap (fill)	Fair				
Earthen Embankment	Fair	Yes

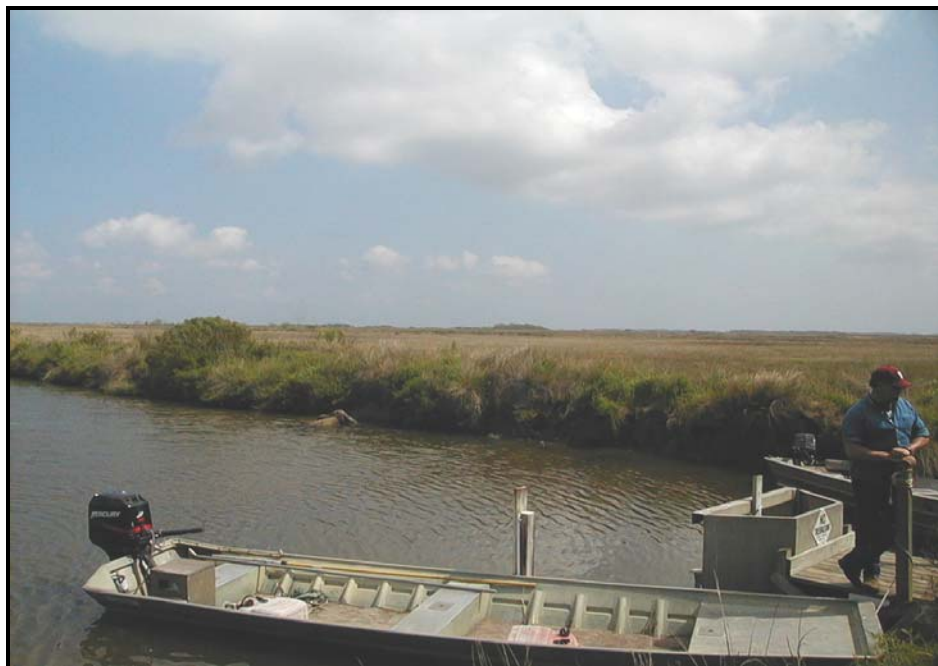
This is also a pre-existing structure that was incorporated into the CS-20 Project. The walkways on the outside and the inside of the structure are missing. The structure is silted up with marsh debris and the stop logs could not be pulled. The bank, however, is showing signs of some erosion and will require approximately 270 tons of man-size rip rap for reinforcement. The bank has additional erosion occurring from the storm. The staff gage on the outside of the structure is missing. LDNR and NRCS agree that maintenance work is required to add rip rap, clean out debris, replace walkway, and replace staff gage. (Photos: Appendix B, Photos 10, 11 & 12).

Photo 10, Structure No.3, March – 2005, showing bankline erosion.

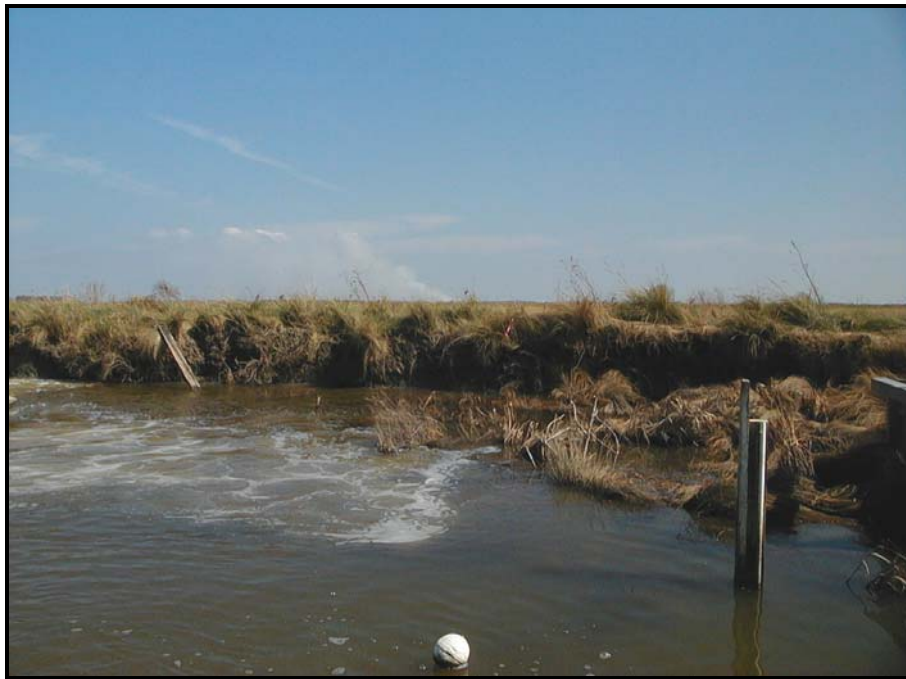
Photo 11, Structure No. 3, November – 2005, showing additional erosion along structure and eastern levee.

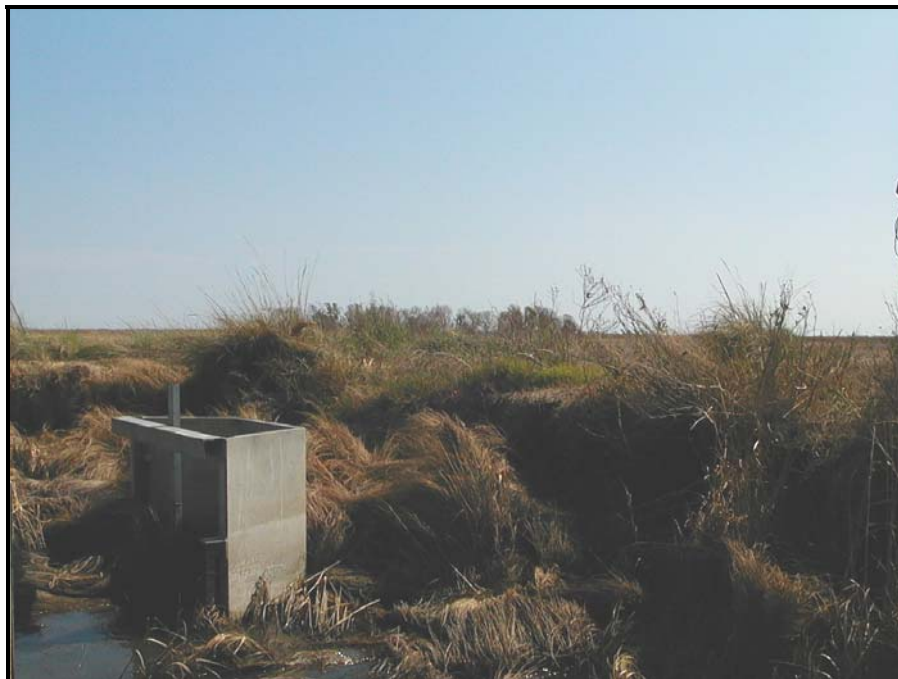
Photo 12, Structure No. 3, showing marsh debris/siltation in and around the structure.

Item	Condition	Physical Damage	Corrosion	Photo #	Observations and Remarks
Steel Bulkhead / Caps	N/A				
Steel Grating	Good				
Stop Logs	Good				
Hardware	Fair		Yes		Corrosion on padlocks.
Timber Piles/ Walkway	Fair				Walkways on the inside and outside of the structure are missing.
Timber Wales	Good				
Galv. Pile Caps	Good				
Cables	Good				
Signage /Supports	Fair				Replace staff gage on inside and outside of the structure.
Rip Rap (fill)	N/A				
Earthen Embankment	Fair	Yes		10, 11	Bank erosion on inside of structure, 75 feet on left side and 25 feet on right .
Channel	Poor			10, 11 12	Bank erosion on outside of structure, 20 feet (Approximately 270 tons of rock total). Inlet side of the structure is silted up with marsh debris.

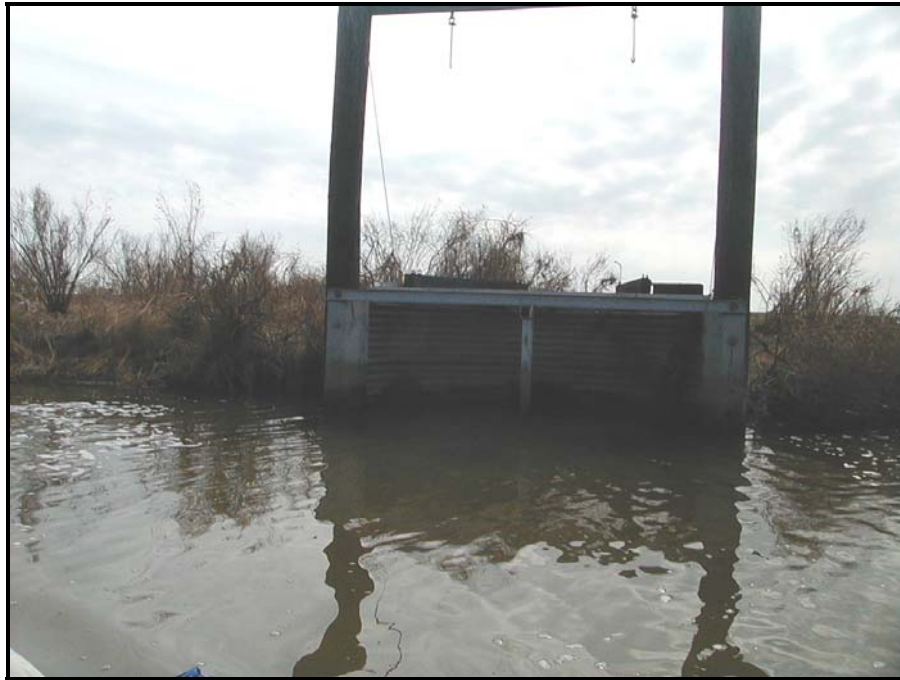
Vandals have stolen the ramp grating on the inlet side of the structure and needs to be replaced. The structure is in mint condition and in no need of any repairs. No water was flowing through the pipe. Water levels were +1.3 inside and +1.4 NAVD outside. LDNR and NRCS agree that no maintenance work required other than replacing the grating. (Photo: Appendix B, Photos 13).

Photo 13, Structure No. 1, view looking south.

Item	Condition	Physical Damage	Corrosion	Photo #	Observations and Remarks
Steel Bulkhead / Caps	N/A				
Steel Grating	Fair			13	Replace one section of grating that is missing.
Stop Logs	Good				<b>NOTE:</b> There was no water flowing through the structure at the time of the inspection.
Hardware	Fair		Yes	13	Corrosion on padlocks.
Timber Piles	Good				
Timber Wales	Good				
Galv. Pile Caps	Good				
Cables	Good				
Signage / Supports	Good				
Rip Rap (fill)	N/A				
Earthen Embankment

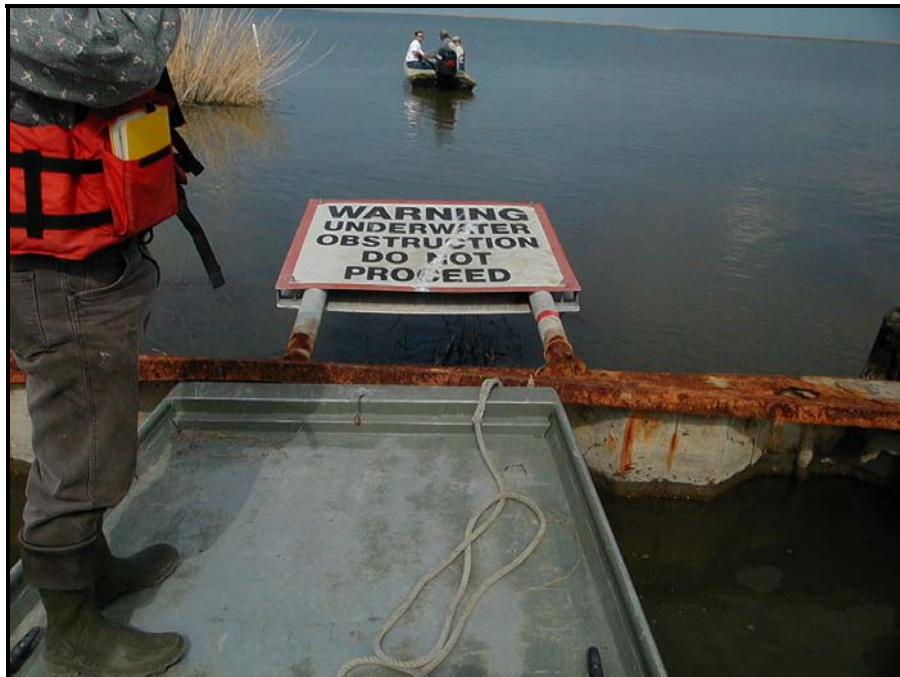
Some rusting of the pile cap is present. The locking tabs on the landing side of the stop log slots are gone and will need to be replaced. The warning sign has been knocked down and in the process has pulled up the pile cap that was supporting it. The staff gauge is leaning and not readable. Salinity on the lake side of the structure was 24.3 ppt. Other features of this structure are in the same condition as pre-storm. LDNR and NRCS agree that maintenance work is required to repair sign and pile cap, replace staff gage, and replace locking tabs. (Photos: Appendix B, Photos 14).

Photo 14, Structure No. 17, showing bent warning sign and damaged pile cap.

Item	Condition	Physical Damage	Corrosion	Photo #	Observations and Remarks
Steel Bulkhead / Caps	Fair			14	Steel sheet pile and cap show signs of corrosion.
Steel Grating	Good				
Stop Logs	N/A				The locking tabs on the stop log slots are missing.
Hardware	Good				
Timber Piles	Good				
Timber Wales	Good				
Galv. Pile Caps	Good				
Cables	Good				
Signage / Supports	Fair			14	Warning sign has been knocked down.
Staff Gages	Poor				Staff gage is leaning and not readable. Salinity on the lake side of the structure was 24.3 ppt.
Rip Rap (fill)	N/A				
Earthen Embankment	Good

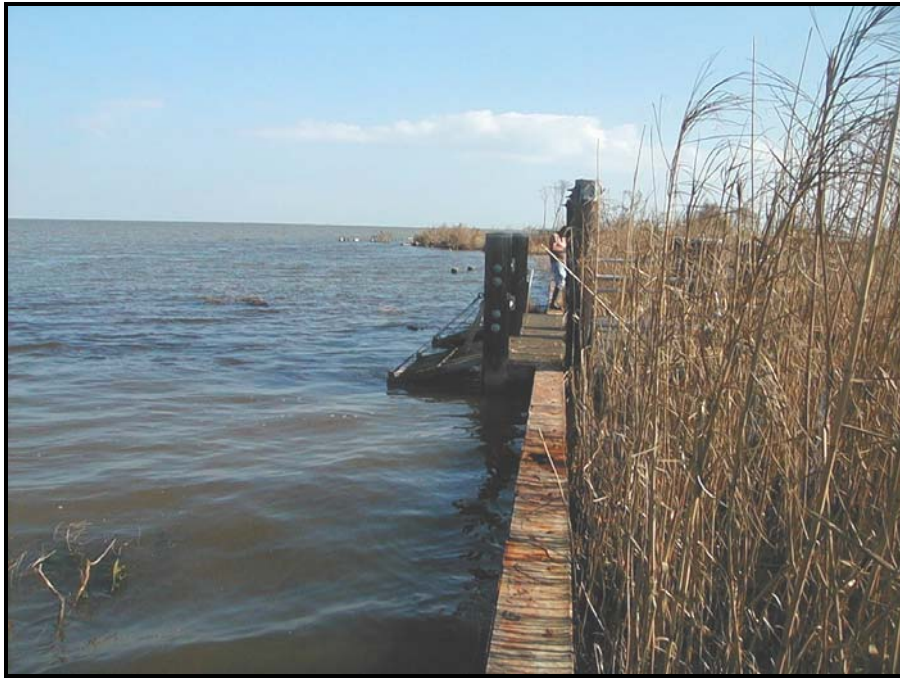
Water was flowing into this structure from First Bayou. The warning sign is missing as well as the staff gauge inside. Staff gauge reading outside was +1.67NAVD88. Salinity inside the marsh was 25.0 ppt and 21.5 ppt on the outside. Remaining project features are in same condition as pre-storm. LDNR and NRCS agree that minor maintenance is required to replace the warning sign. (Photos: Appendix B, Photo 15).

Photo 15, Structure No. 13, view looking south, flap gates open.

Item	Condition	Physical Damage	Corrosion	Photo #	Observations and Remarks
Steel Bulkhead / Caps	Fair			15	Some rusting of pile cap is present.
Steel Grating	Good				
Stop Logs	Good				<b>Note:</b> Water was flowing into project from First Bayou.
Hardware	Good				
Timber Piles	Good				
Timber Wales	Good				
Galv. Pile Caps	Good				
Cables					
Signage / Supports	Fair				Warning sign is missing.
Staff Gage	Fair				Staff gage inside is missing.
Rip Rap (fill)					
Earthen Embankment

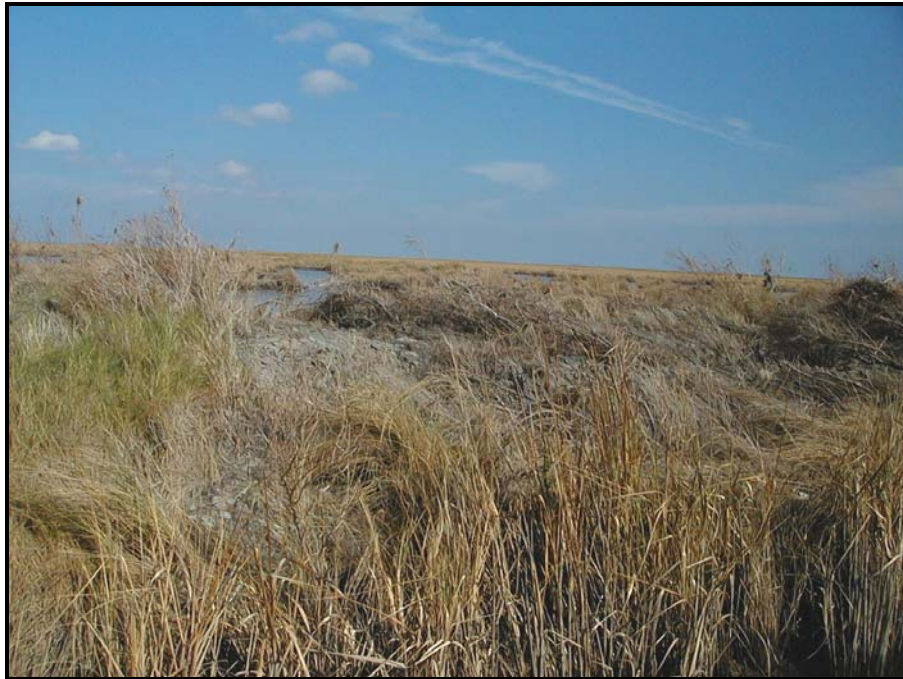
The inspection of the earthen levee consisted of a visual inspection of the entire length of levee along the Step Canal. In addition to the erosion noted at Structures No. 5 and 3, the storm surge has eroded portions of the levee in various locations. In addition the storm surge has placed large amounts of marsh and other debris into the east-west sections of the Step Canal. In these areas of the canal, the water depth was very shallow. The north-south sections appear to be relatively free of any obstructions. LDNR and NRCS agree that maintenance is required to repair the levees and remove trash from the canal. (Photos: Appendix B, Photos 16, 17 & 18).

Photo 16, North Levee, looking east, showing washout of top portion of levee.

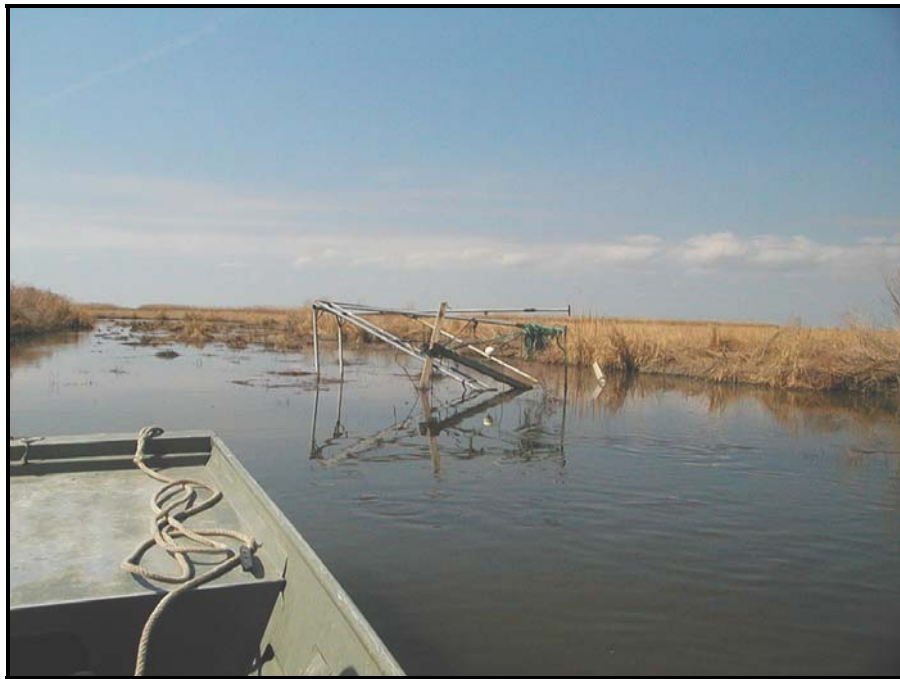
Photo 17, Step Canal, view looking west, showing marsh/siltation and other debris in the canal.

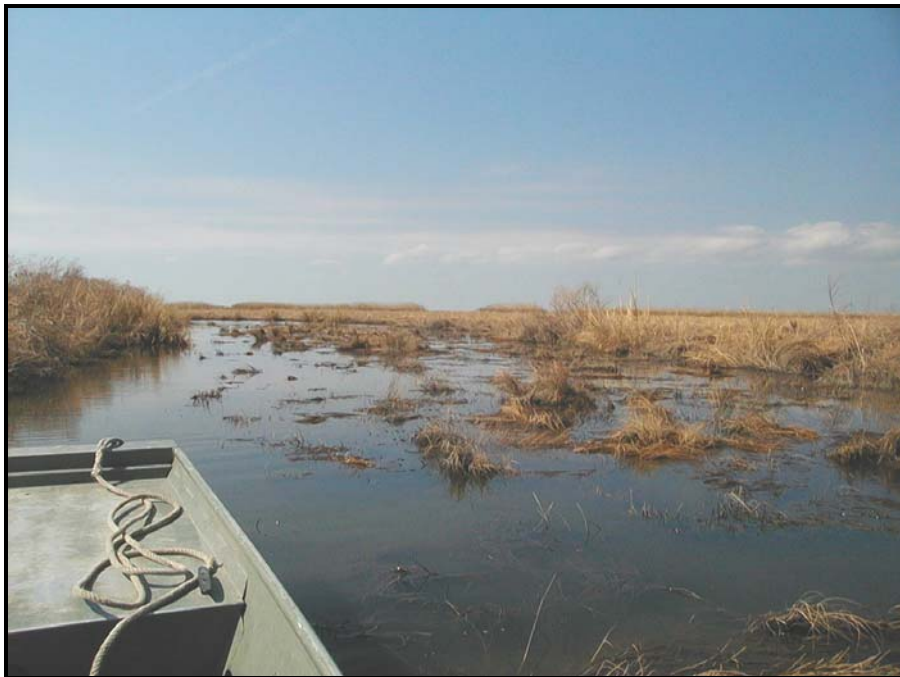
Photo 18, Step Canal, view looking west, again showing heavy marsh siltation in the canal.
